APPLICATIONS OF THE SHOCK PULSE TECHNIQUES TO HELICOPTER DIAGNOSTICS

Timothy C. Mayer
Edward F. Covill
John A. George
J. Thomas Harrington

24 February 1975

Final Report.

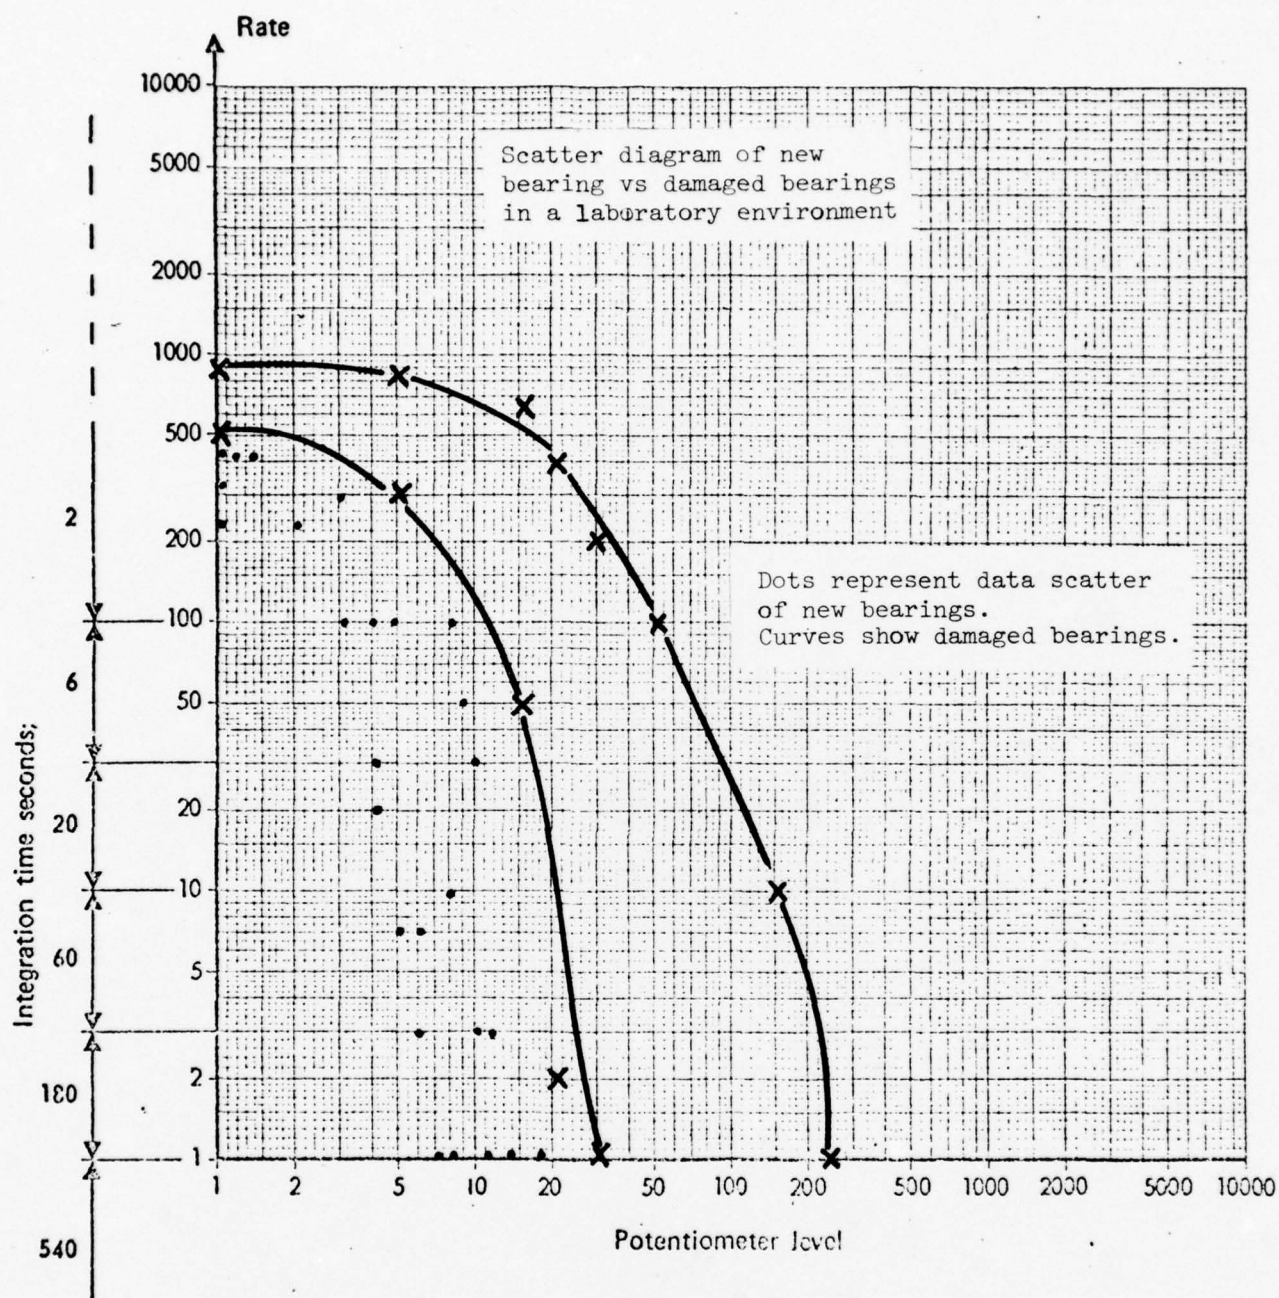
Fig. 3.1

Figure 3.1 shows the differences in the shock emissions of new bearings compared to bearings with an unserviceable condition which were rejected for use in aircraft by the US Army inspection facility USAAVNS, Ft. Rucker, Alabama. The higher rates and levels of the unserviceable bearings are apparent. Figure 3.2 is made from a comparison of three specific types of damage: 1) Dirty lubricant, 2) Rolling element damage, 3) "Dry bearing" with insufficient lubricant. The damage was induced artificially on new bearings which are represented on the graph as data scatter of new bearings. There is little correlation to the theoretical curve shapes of Figure 2.0. However, again the rates and levels of the damaged bearings are greater than those of new or undamaged ones.

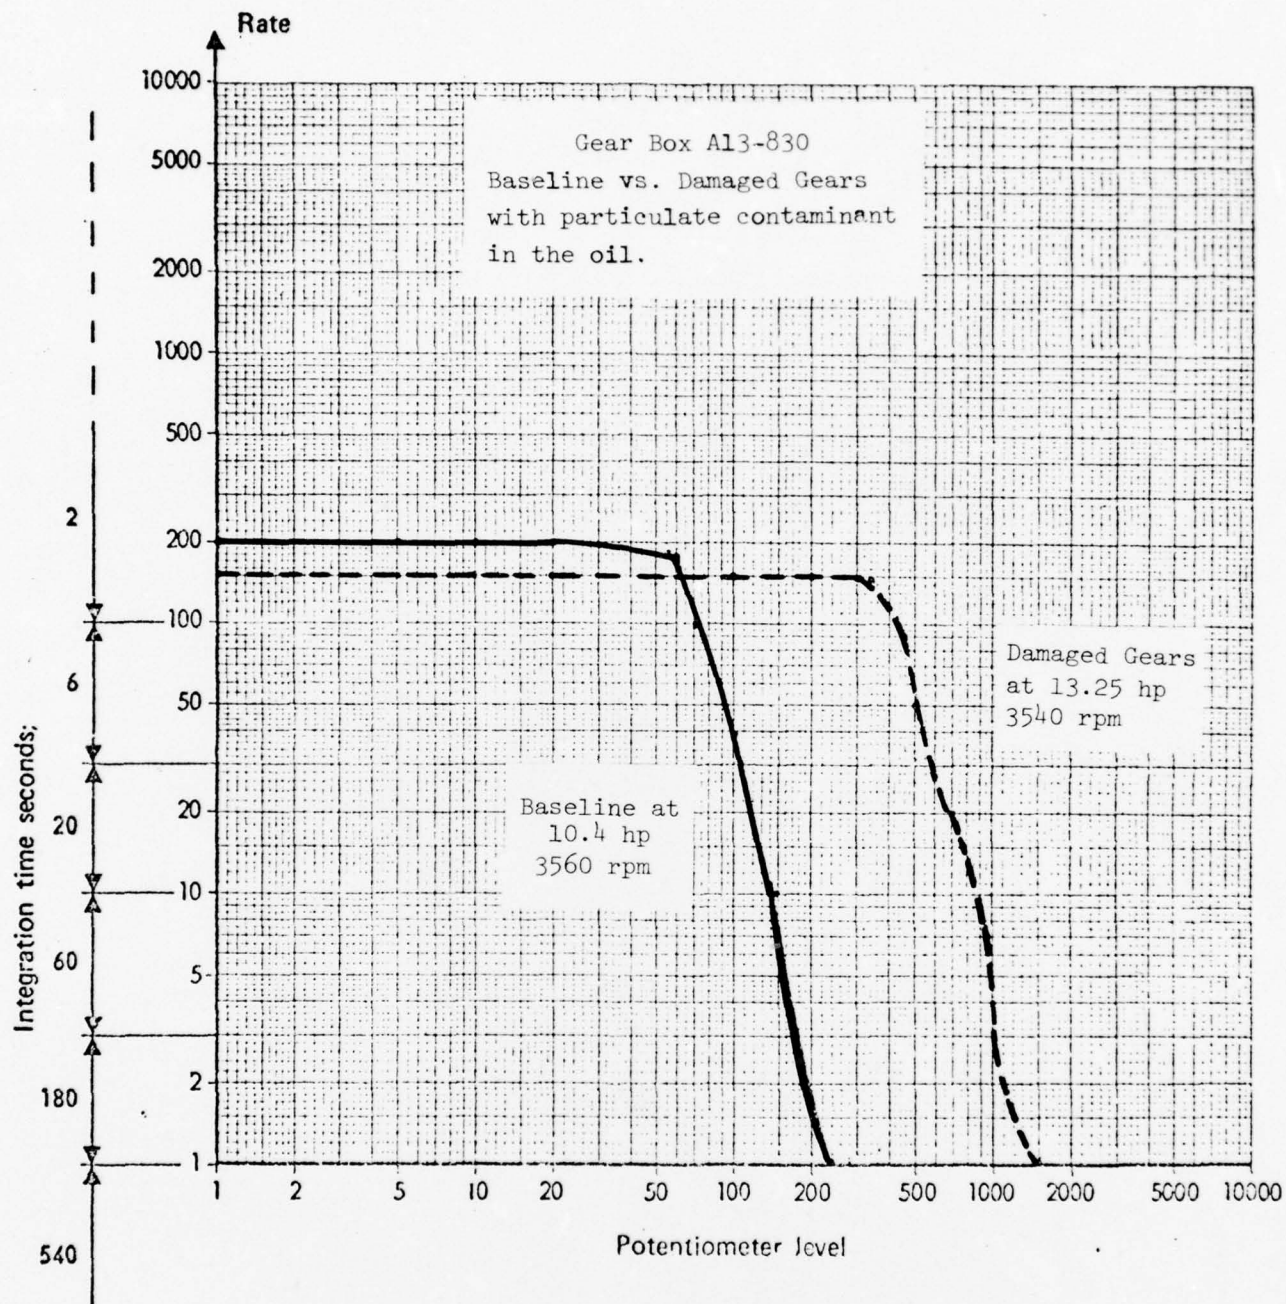
Fig. 3.7

Figure 3.7 illustrates the ability of the shock pulse technique to isolate foreign matter present in the lubricant of a 42^o gear box run on a laboratory test facility. The foreign matter was a result of debris from damaged gears implanted in the assembly.

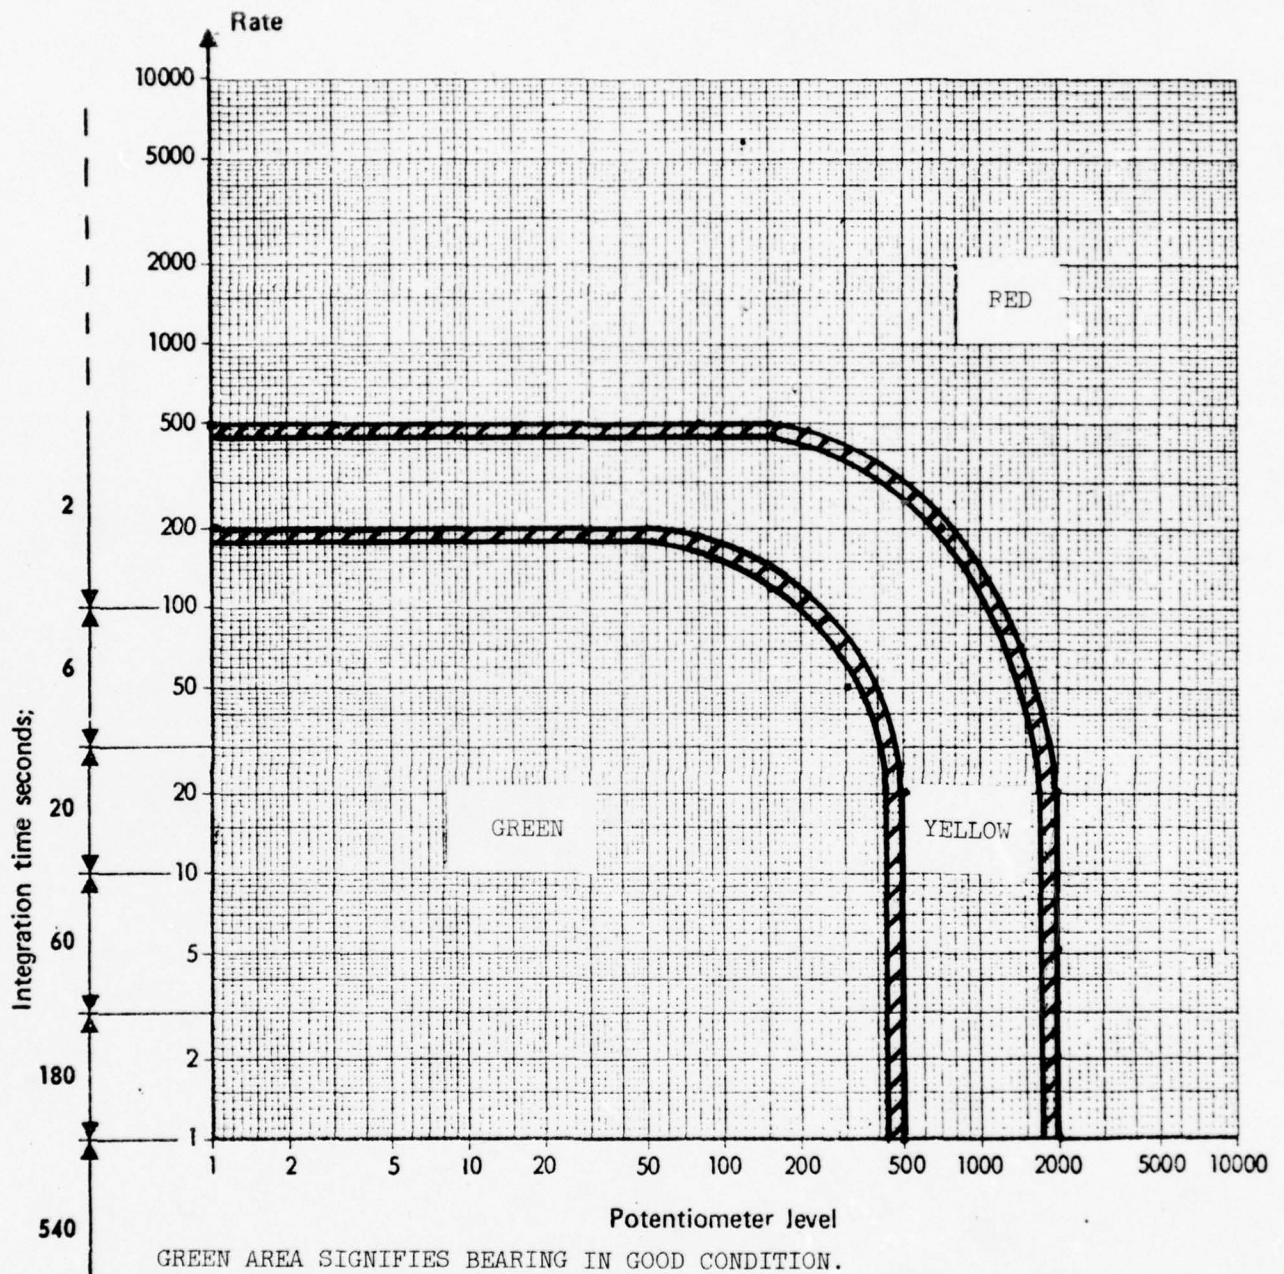
The extensive hanger bearing data has been summarized in a single damage-assessment shock emission curve (Fig. 4.4). The

data indicates a new or normal wear hanger bearing would have a shock level of less than 500 units.

GREEN AREA SIGNIFIES BEARING IN GOOD CONDITION.

YELLOW AREA DENOTES A BEARING WITH DAMAGE AND REPRESENTS A MARGINAL CONDITION AREA.

RED AREA SIGNIFIES A BEARING WITH DAMAGE IN EXCESS OF THAT WHICH WE FEEL WOULD BE ACCEPTABLE.

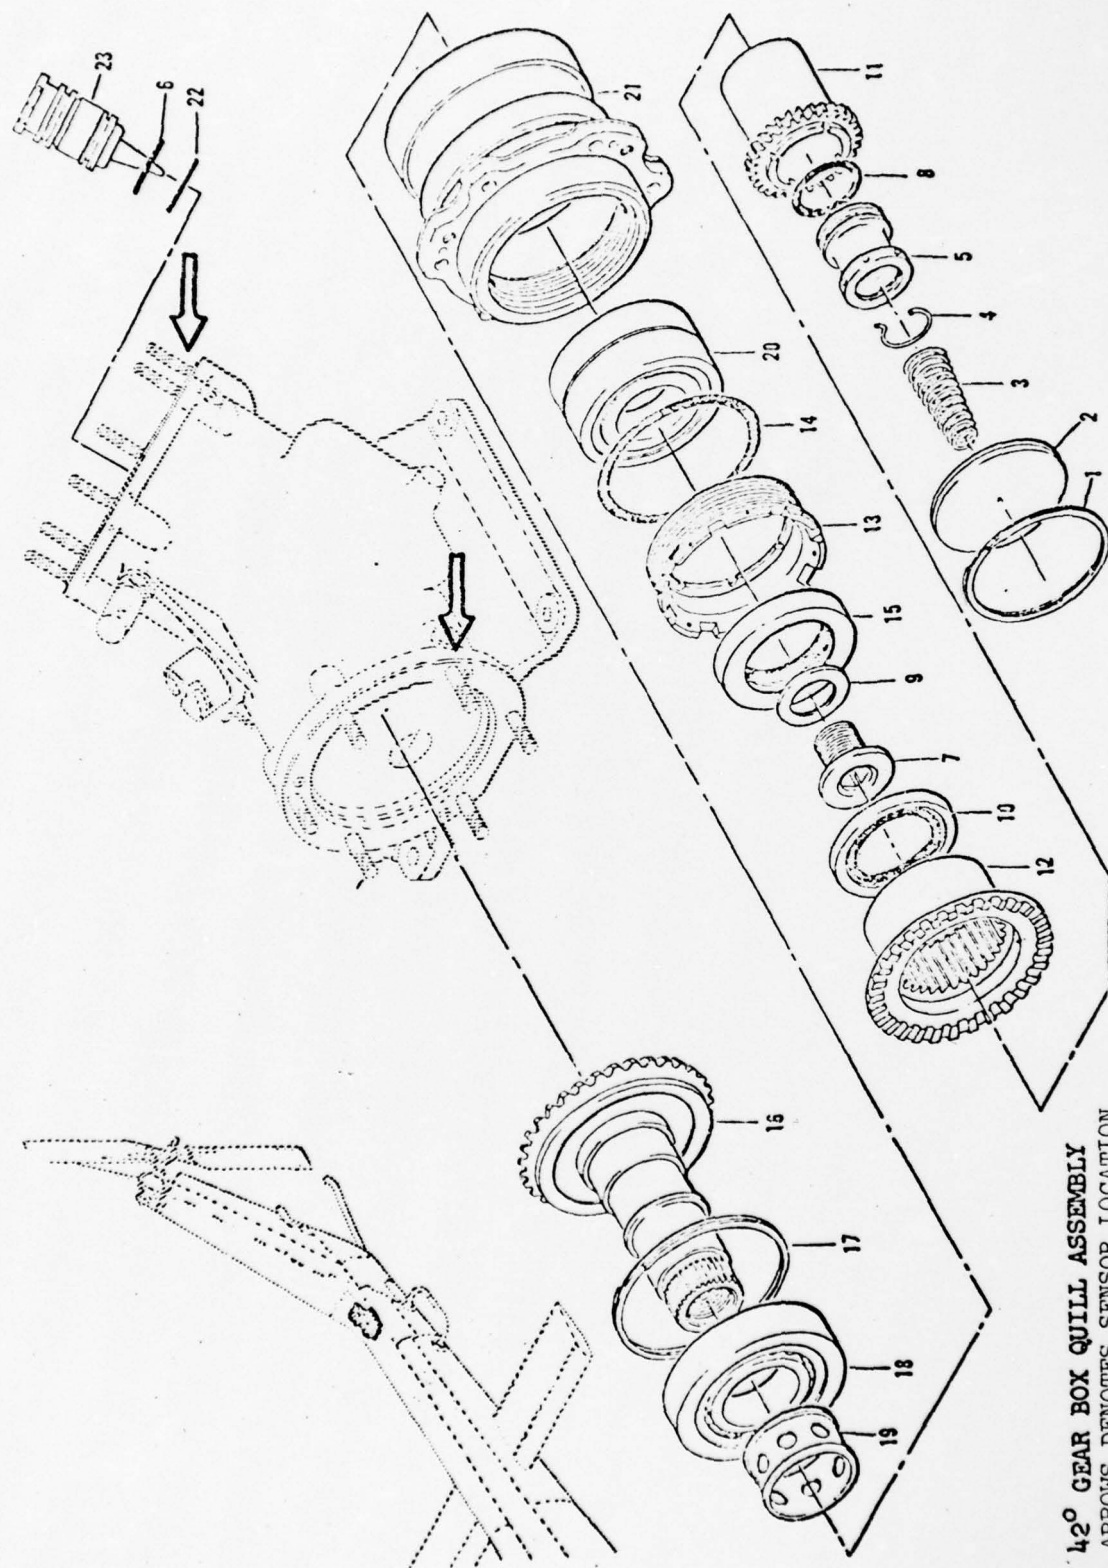
Fig. 4.6

Figure 4.6 represents a 42° gear box with damage which progressed during a test run. A duplex ball bearing, with a single shallow spall approximately 0.08" x 0.08" in the outer race, was implanted in a 42° gear box. Of particular interest was the observation of progressive damage while the test was in progress. The shape of the shock emission curve changed continuously over a period of minutes in both rate and shock level. The Figure shows two curves developed on a single run. A change in slope takes place (A), a sharp increase in rate (B-C), a continual change in slope (C-D). Without shutting down the engine, the second curve (E-F-G) was developed. After engine shut-down, an oil sample analysis revealed traces of metal, although not beyond that considered acceptable. The dotted line is an extrapolation of the initial slope and gives an indication of the shock level stabilizing at a factor of ten higher. Two more runs were made which essentially repeated curve E-F-G. Teardown analysis showed that the original degradation had not changed noticeably but that new spalls were found on the outer race and on one ball bearing.

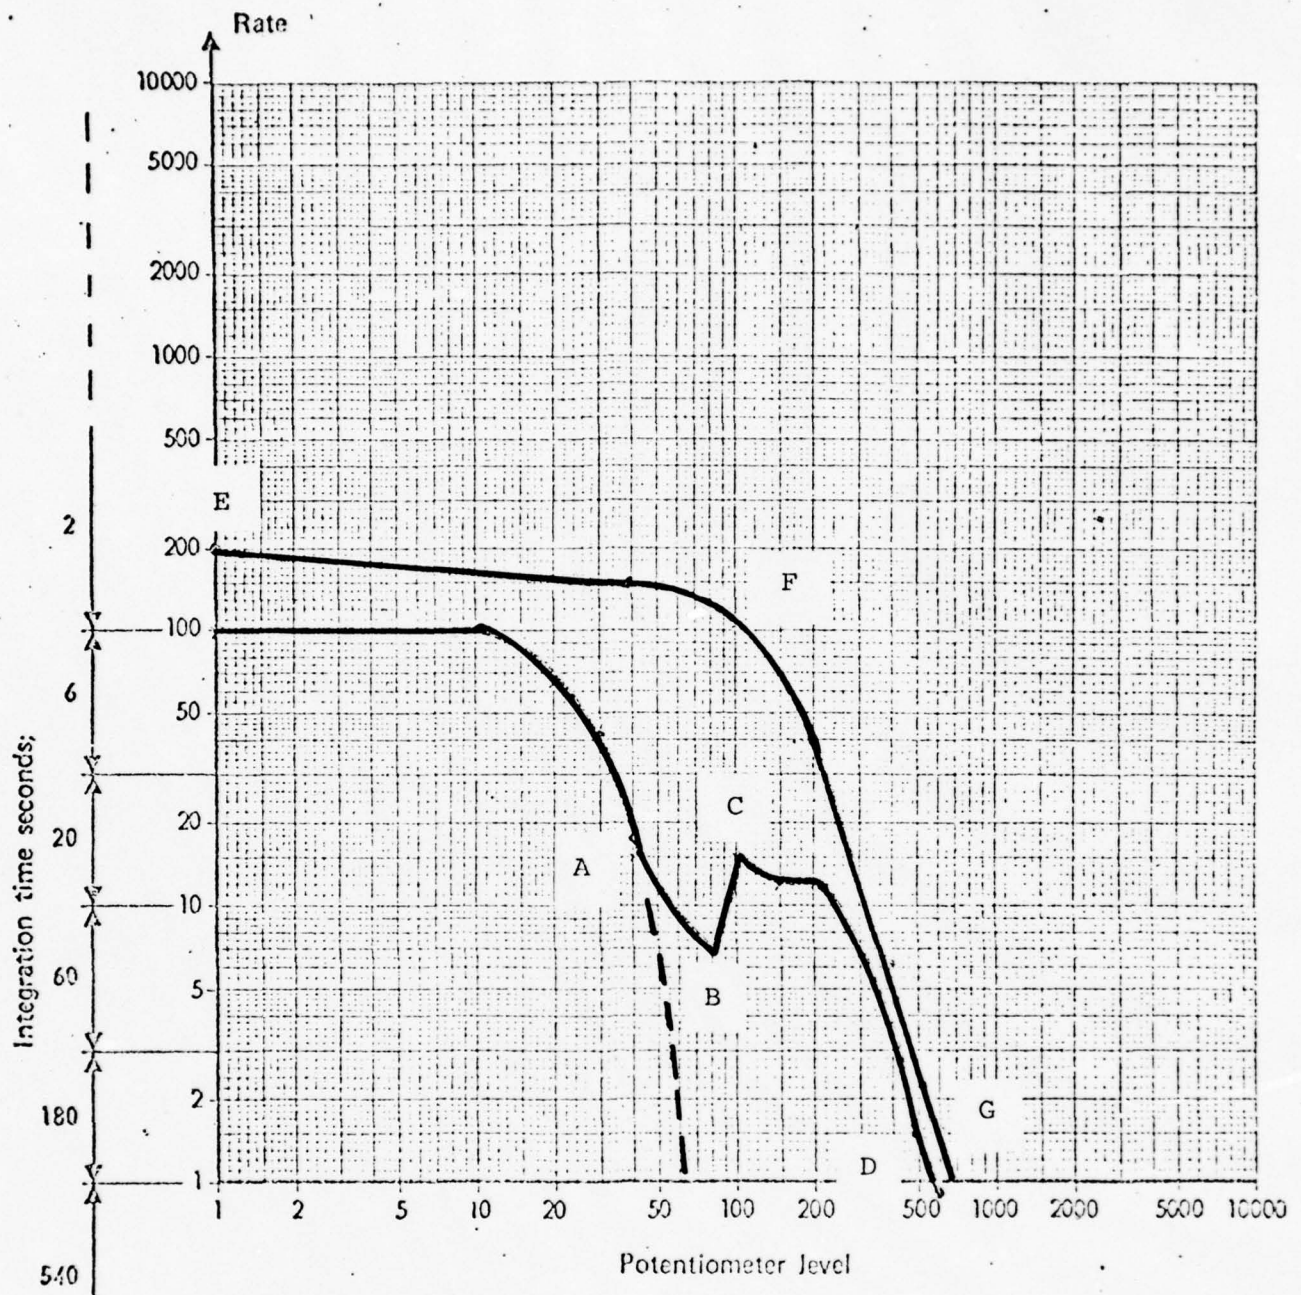
42° GEARBOX IMPLANTED WITH A SPALLED DUPLEX BALL BEARING

EVIDENCE OF DAMAGE PROGRESSING

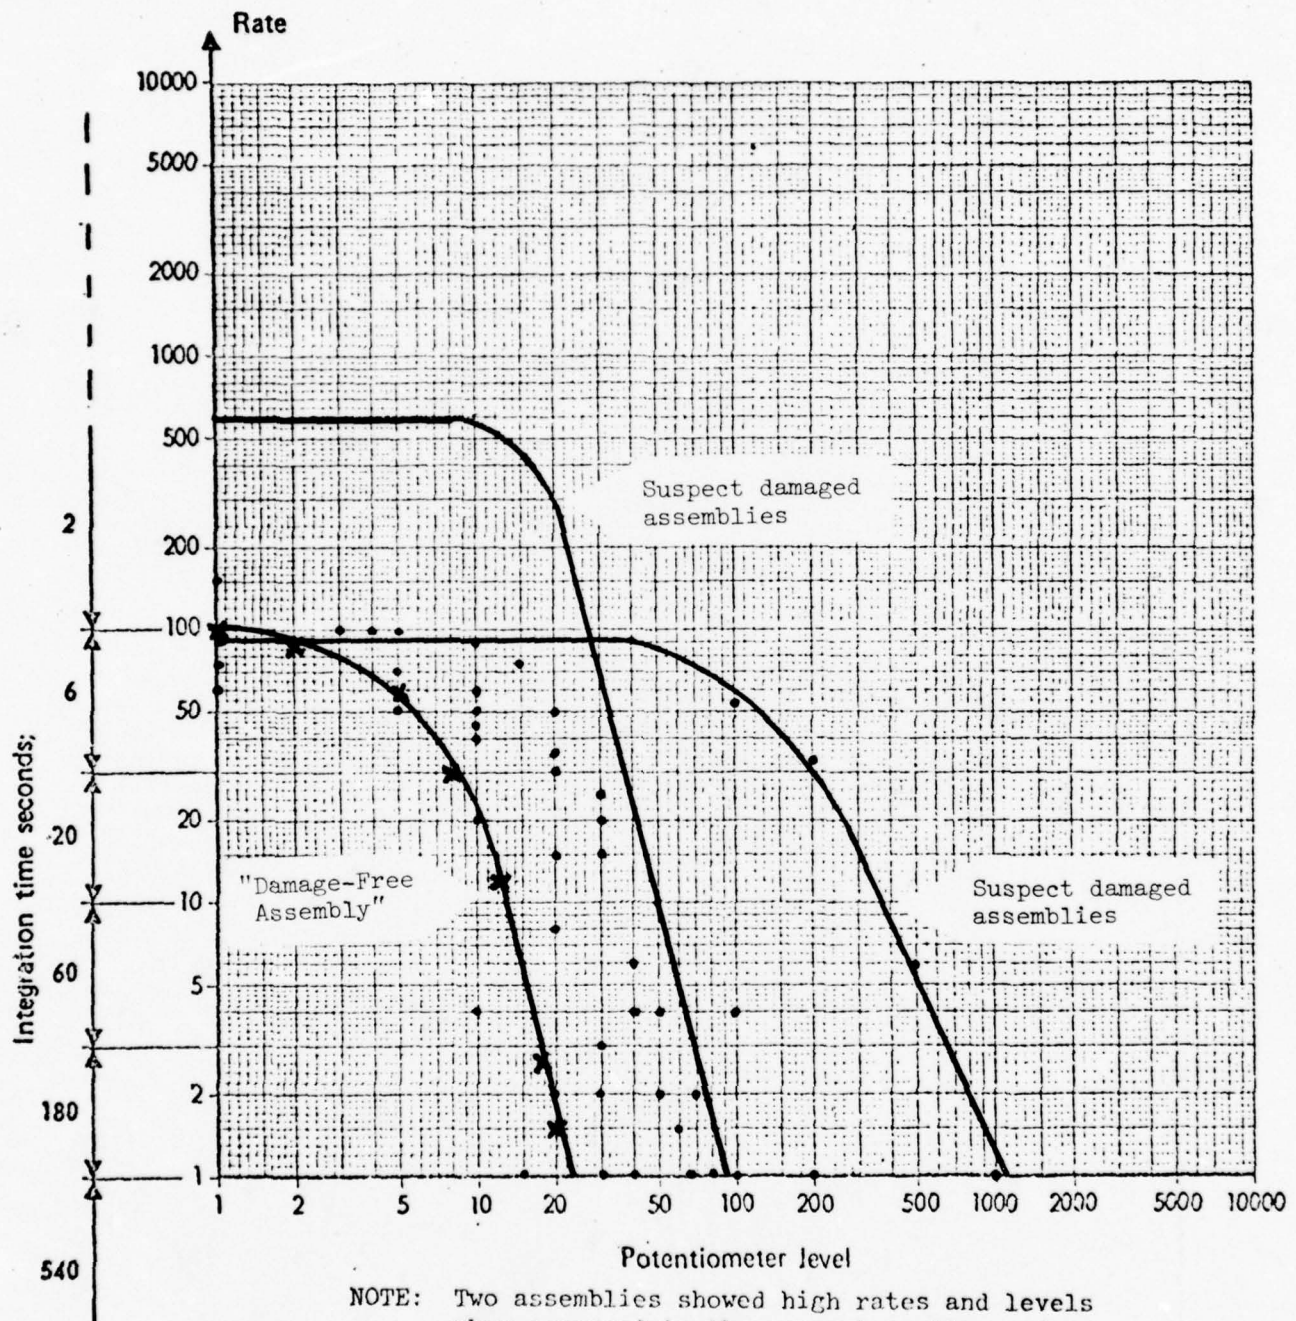
Fig. 4.10

SUMMARY CHART OF 10 90° GEAR BOX
ASSEMBLIES SHOWING DATA SCATTER

NOTE: Two assemblies showed high rates and levels when compared to the general scatter and a "damage-free assembly".

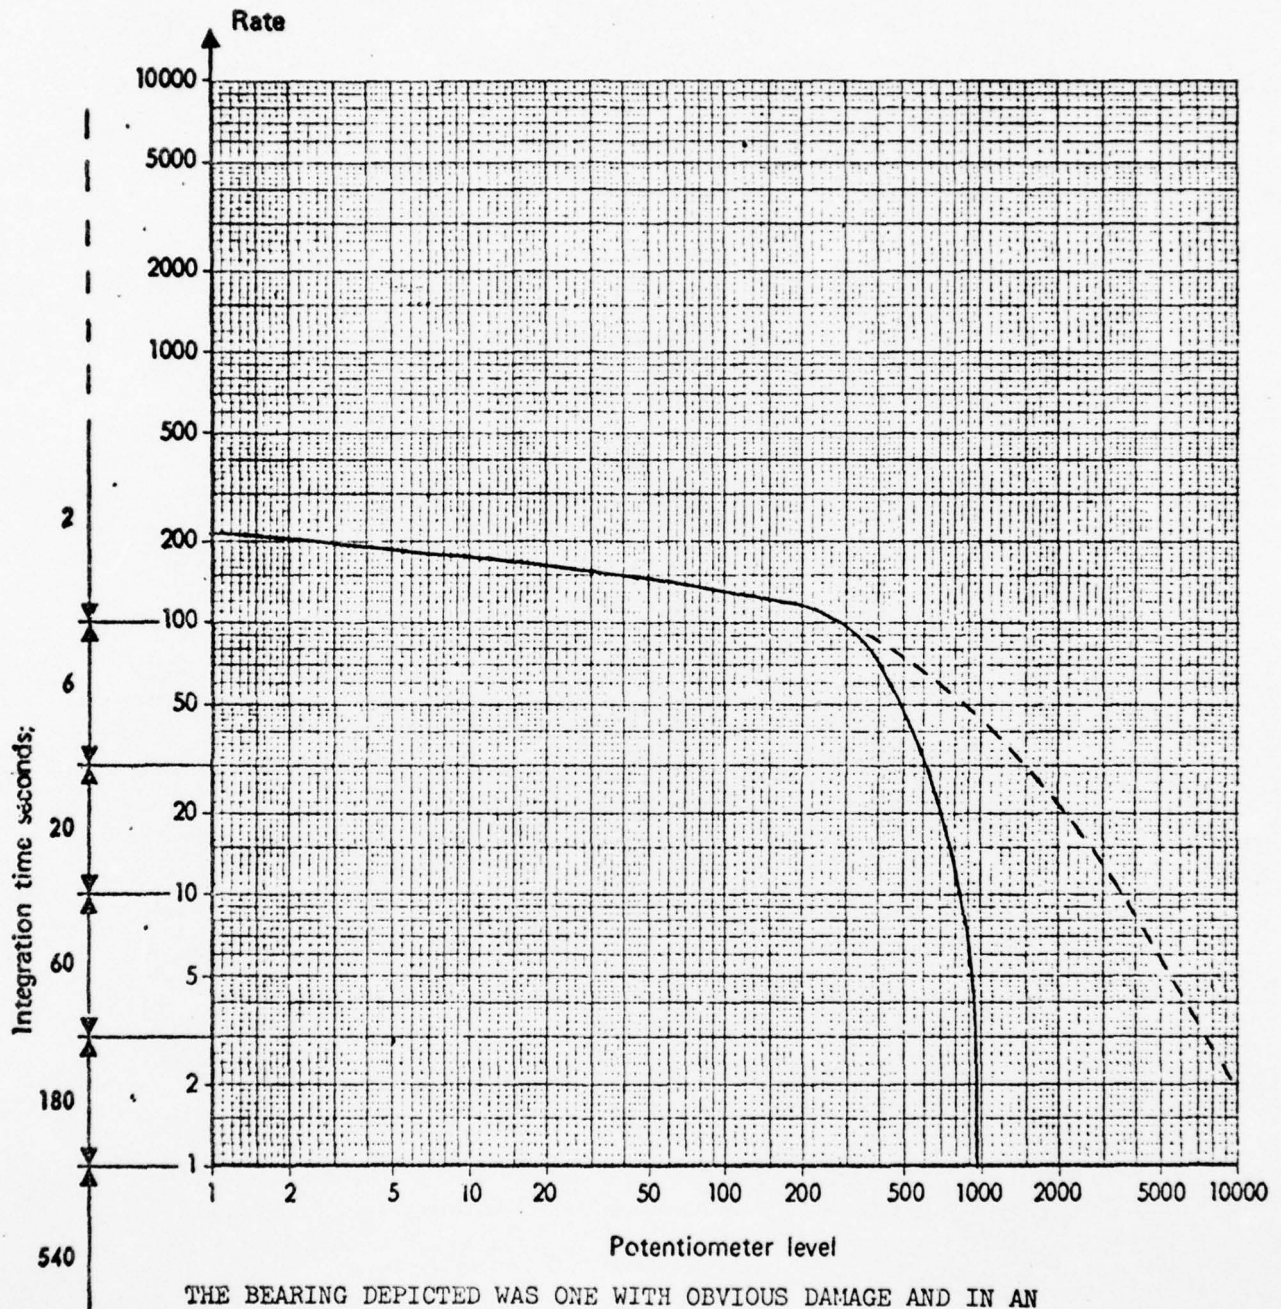
THE BEARING DEPICTED WAS ONE WITH OBVIOUS DAMAGE AND IN AN
UNSERVICEABLE CONDITION LISTED AS "ROUGH AND DRY".

THREE CURVES WERE PLOTTED ON THE SAME BEARING, ALL OF WHICH
SHOW CLEARLY THE DAMAGE IN THE HIGH POTENTIOMETER LEVELS, WHICH IN
SOME CASES SEEMED TO EXTEND TO INFINITY, INDICATIVE OF SEVERE ROLLING ELEMENT DAMAGE.

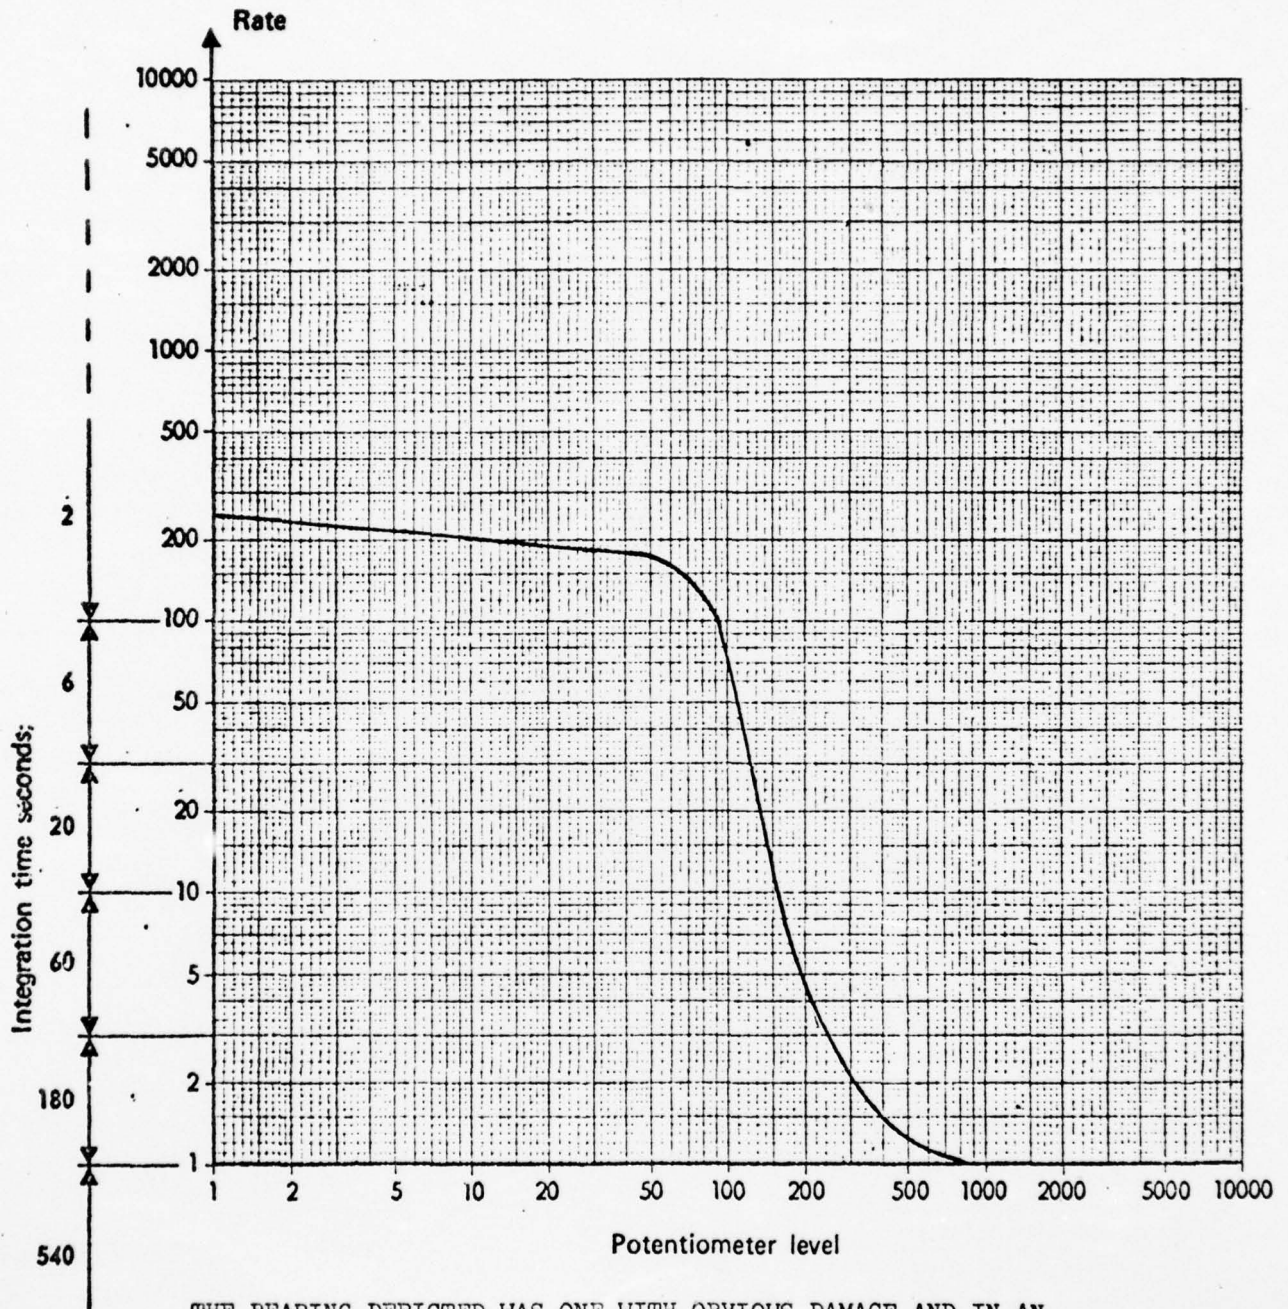
THE BEARING DEPICTED WAS ONE WITH OBVIOUS DAMAGE AND IN AN
UNSERVICEABLE CONDITION LISTED AS "ROUGH AND DRY".

THREE CURVES WERE PLOTTED ON THE SAME BEARING, ALL OF WHICH
SHOW CLEARLY THE DAMAGE IN THE HIGH POTENTIOMETER LEVELS, WHICH IN
SOME CASES SEEMED TO EXTEND TO SEVERE ROLLING ELEMENT DAMAGE.

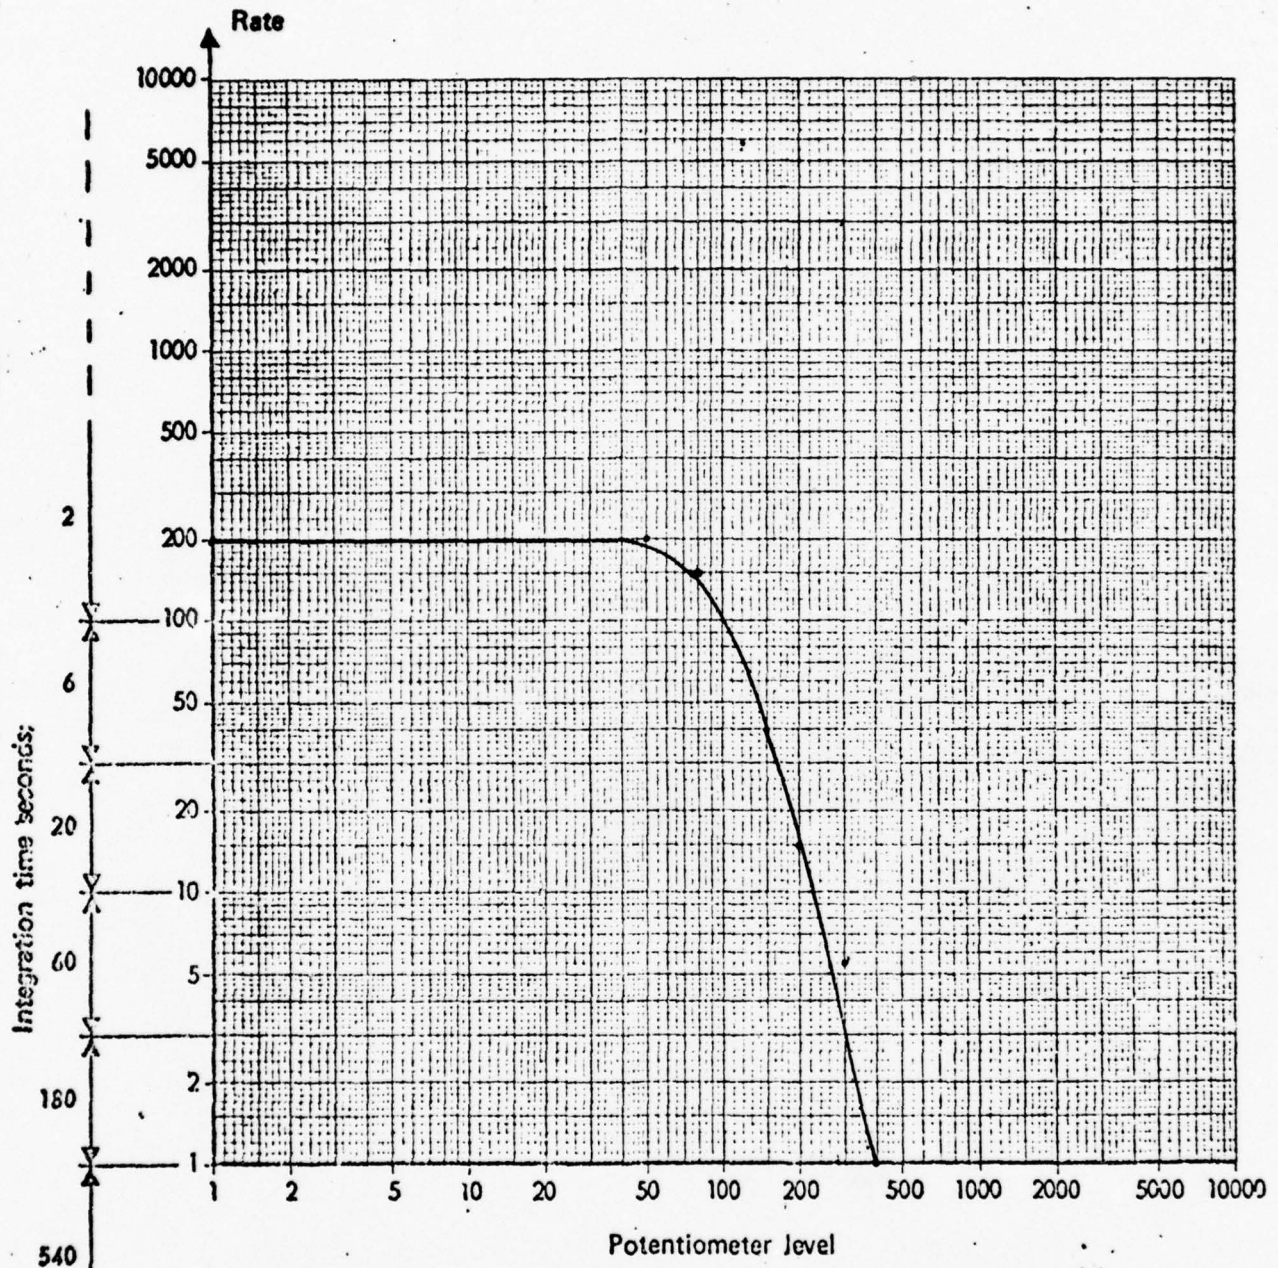
BEARING DEPICTS CURVE ABOVE NORMAL BUT A CONSIDERATION OF DAMAGE EVIDENCE IN TEARDOWN INSPECTION MUST BE MADE PRIOR TO A DETERMINATION THIS BEARING IS EXCESSIVELY DAMAGED.

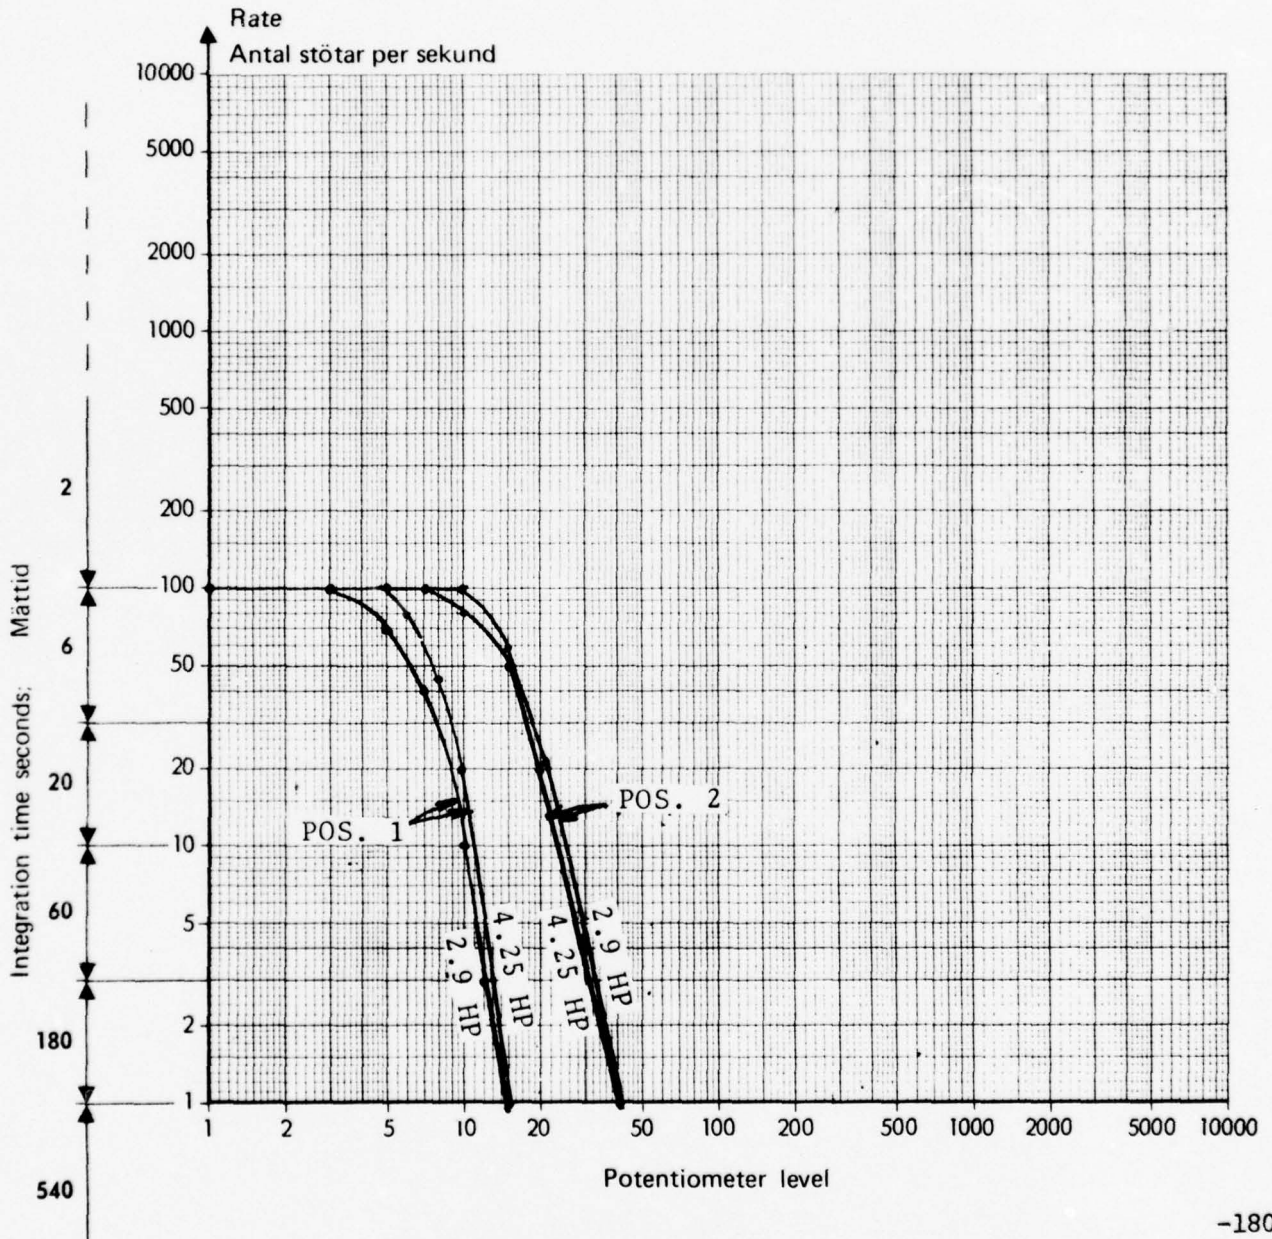
S/N A13 - 830
HEAVILY DAMAGED GEARS
